**CITY OF BALTIMORE WET WEATHER CONSENT DECREE  
SMOKE AND DYED WATER TESTING FORM**

Test ID: S1039-011

CITY OF BALTIMORE  
SMOKE TESTING OBSERVATION SUMMARY  
OUTFALL SEWERSHED  
BALTIMORE CITY PROJECT 1039  
REI/DRAYCO

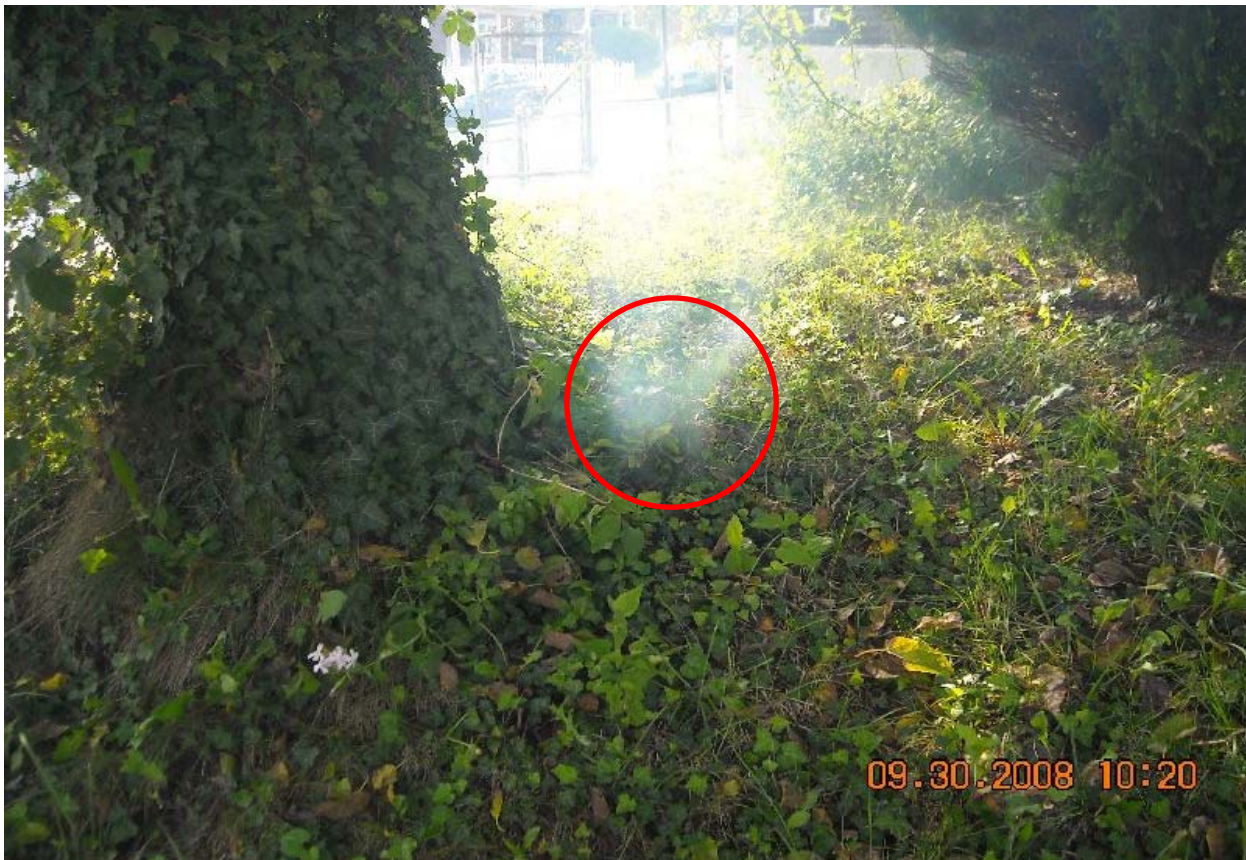
Photograph No: OB01-P01  
Filename: S1039-011\_OB01-P01.jpg

Unique Test ID: S1039-011	Date: 09/30/2008	Manhole ID: S49II_032MH
Defect No: OB01	Supervisor: E.R.	Basin: Outfall
Location: 2821 E. FEDERAL ST.		
Source Type: 03 Cleanout	Sector: 02 Private	
Location: 07 Yard - Front	Severity: 03 Moderate	Drainage Area: 1 ft <sup>2</sup>
Comments: Smoke is coming from a cleanout with a broken cap at 2821 E. Federal Ave.

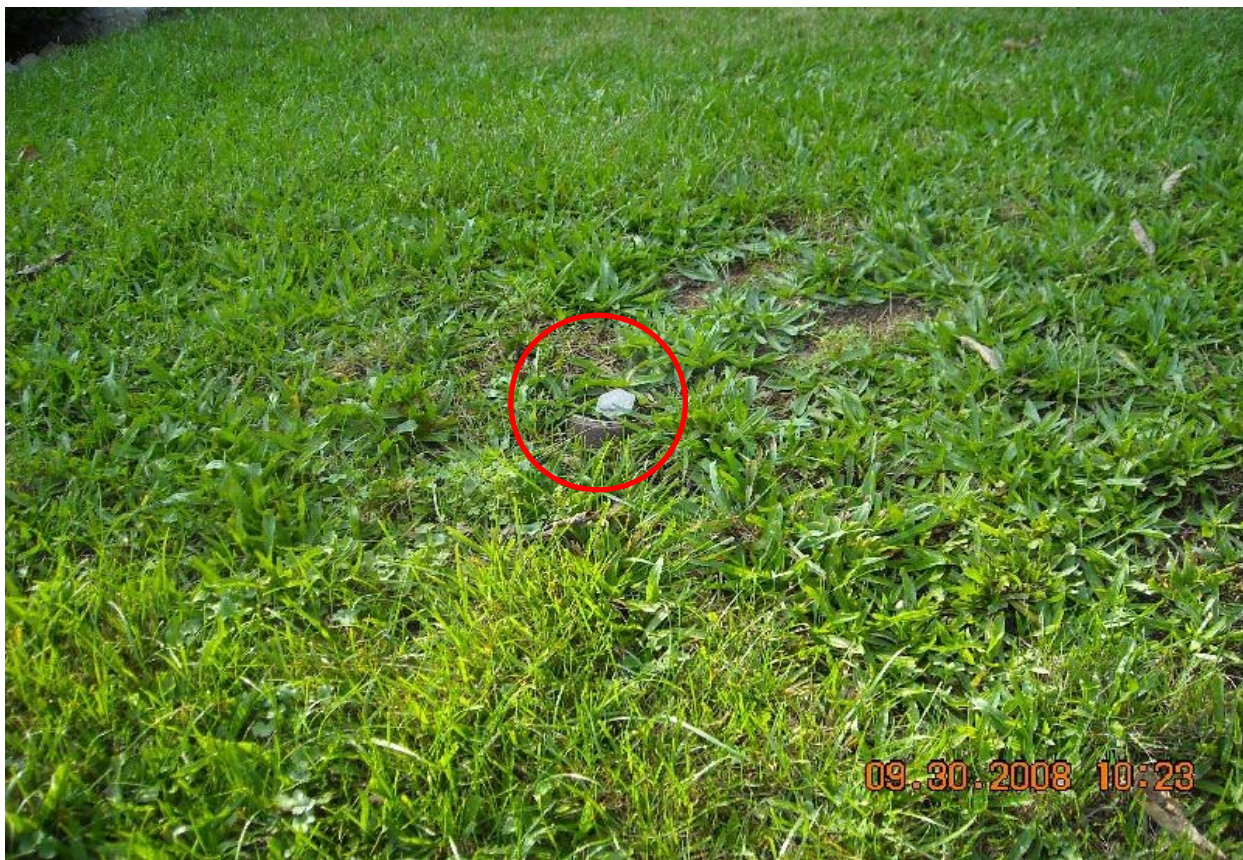
Photograph No: OB02-P01  
Filename: S1039-011\_OB02-P01.jpg

Unique Test ID: S1039-011	Date: 09/30/2008	Manhole ID: S49II_032MH
Defect No: OB02	Supervisor: E.R.	Basin: Outfall
Location: 2839 E. FEDERAL ST.		
Source Type: 03 Cleanout	Sector: 02 Private	
Location: 07 Yard - Front	Severity: 02 Trace	Drainage Area: 1 ft <sup>2</sup>
Comments: Smoke is coming from above grade cleanout with a broken cap at 2839 E. Federal St.

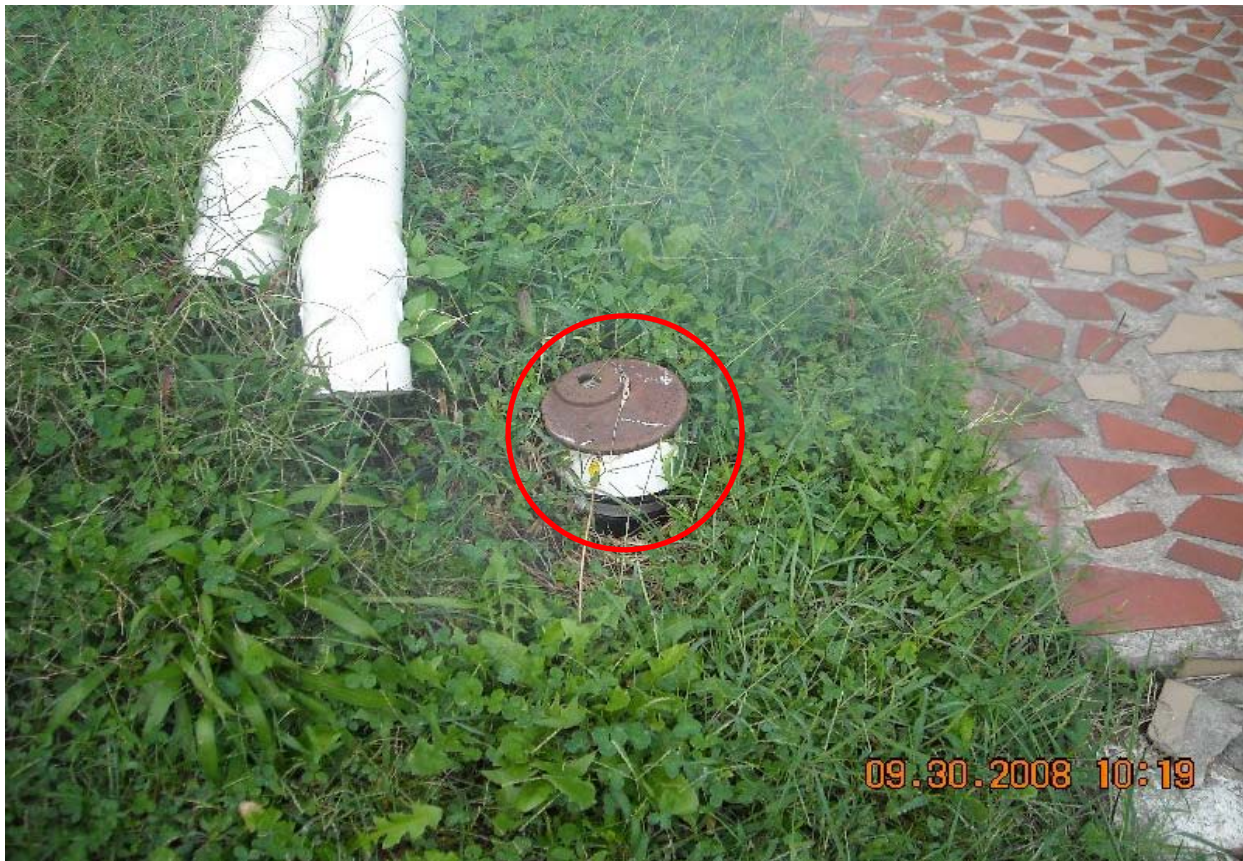
Photograph No: OB03-P01  
Filename: S1039-011\_OB03-P01.jpg

Unique Test ID: S1039-011	Date: 09/30/2008	Manhole ID: S49II_032MH
Defect No: OB03	Supervisor: E.R.	Basin: Outfall
Location: 1506 KENHILL AVE.		
Source Type: 03 Cleanout	Sector: 02 Private	
Location: 07 Yard - Front	Severity: 03 Moderate	Drainage Area: 1 ft <sup>2</sup>
Comments: Smoke is coming from an above grade cleanout in front of 1506 Kenhill Ave.

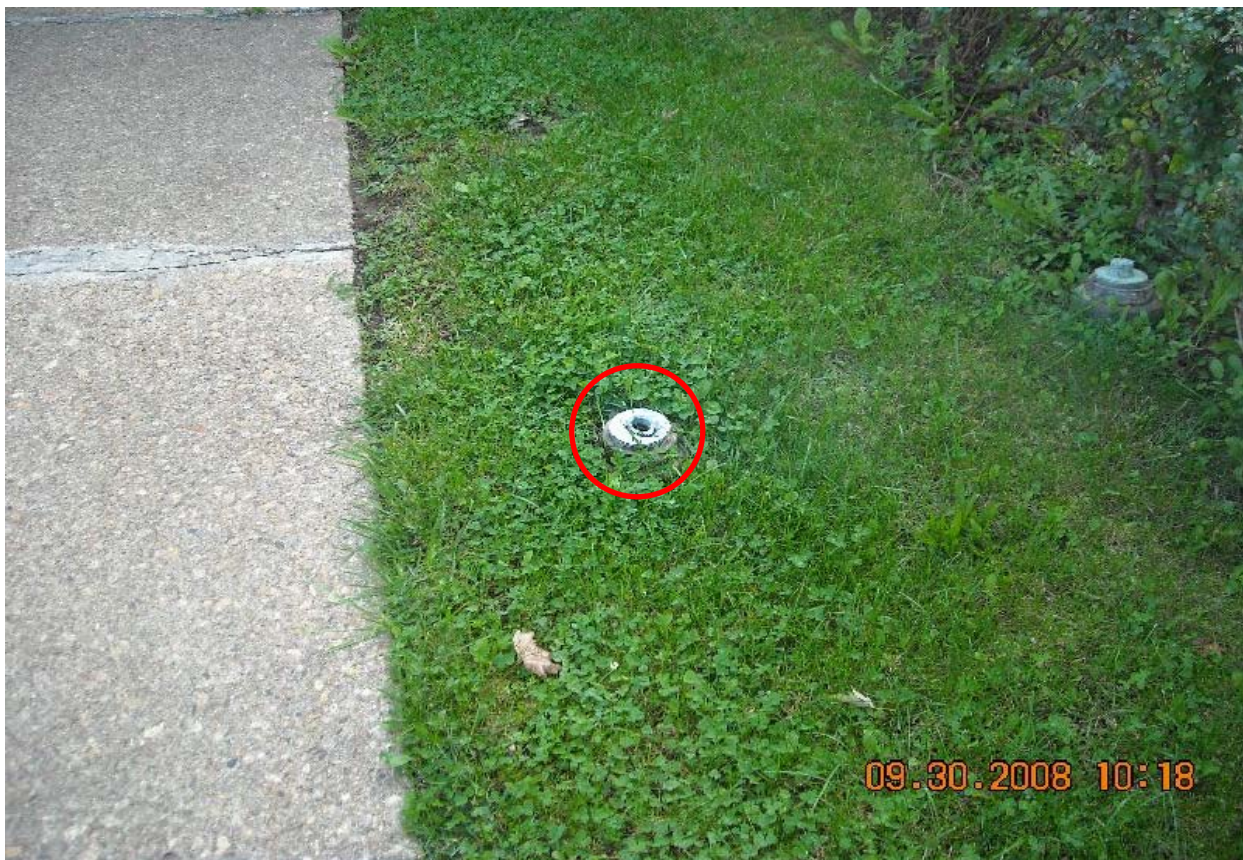
Photograph No: OB04-P01  
Filename: S1039-011\_OB04-P01.jpg

Unique Test ID: S1039-011	Date: 09/30/2008	Manhole ID: S49II_032MH
Defect No: OB04	Supervisor: E.R.	Basin: Outfall
Location: 1507 KENHILL AVE.		
Source Type: 03 Cleanout	Sector: 02 Private	
Location: 07 Yard - Front	Severity: 02 Trace	Drainage Area: 1 ft <sup>2</sup>
Comments: Smoke is coming from an above grade cleanout with a broken cap at 1507 Kenhill Ave.

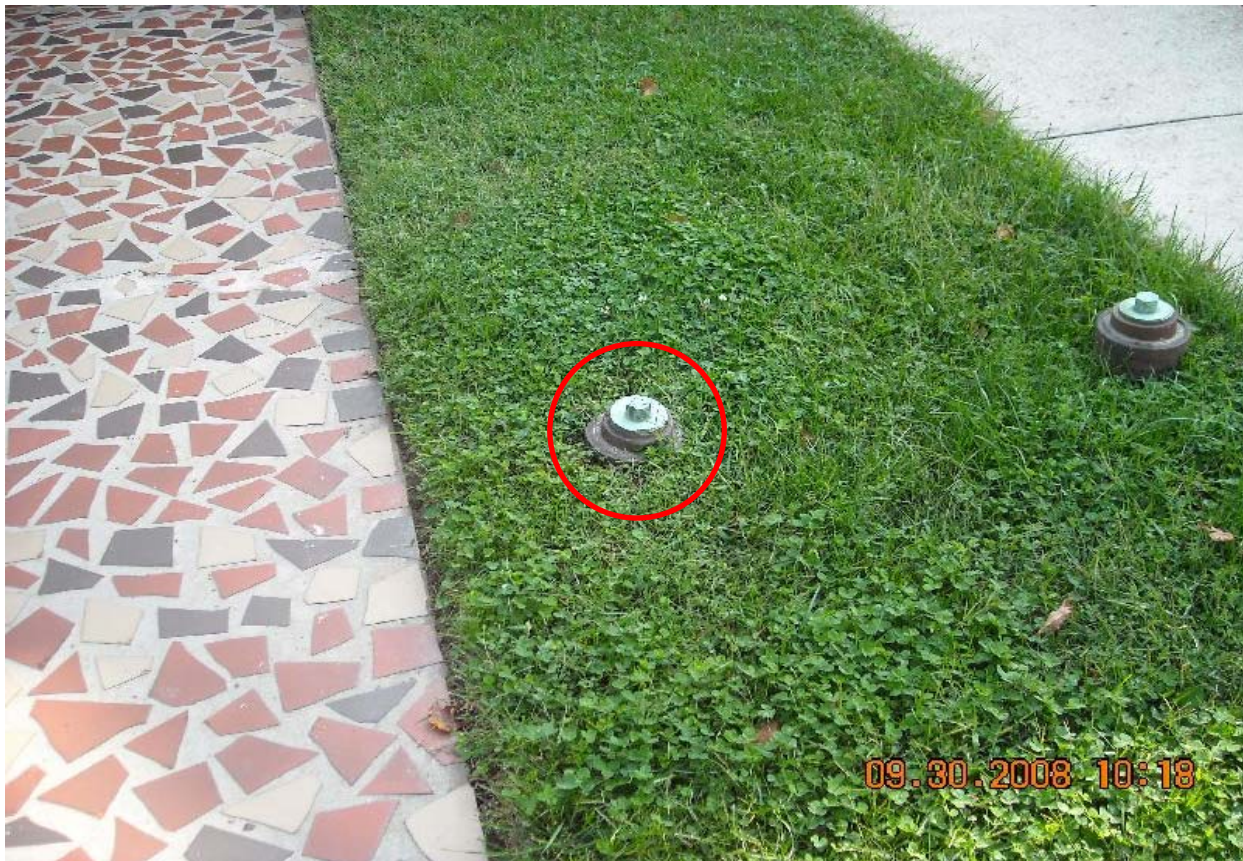
Photograph No: OB05-P01  
Filename: S1039-011\_OB05-P01.jpg

Unique Test ID: S1039-011	Date: 09/30/2008	Manhole ID: S49II_032MH
Defect No: OB05	Supervisor: E.R.	Basin: Outfall
Location: 1513 KENHILL AVE.		
Source Type: 03 Cleanout	Sector: 02 Private	
Location: 07 Yard - Front	Severity: 03 Moderate	Drainage Area: 1 ft <sup>2</sup>
Comments: Smoke is coming from above grade cleanout with a broken cap at 1513 Kenhill Ave.

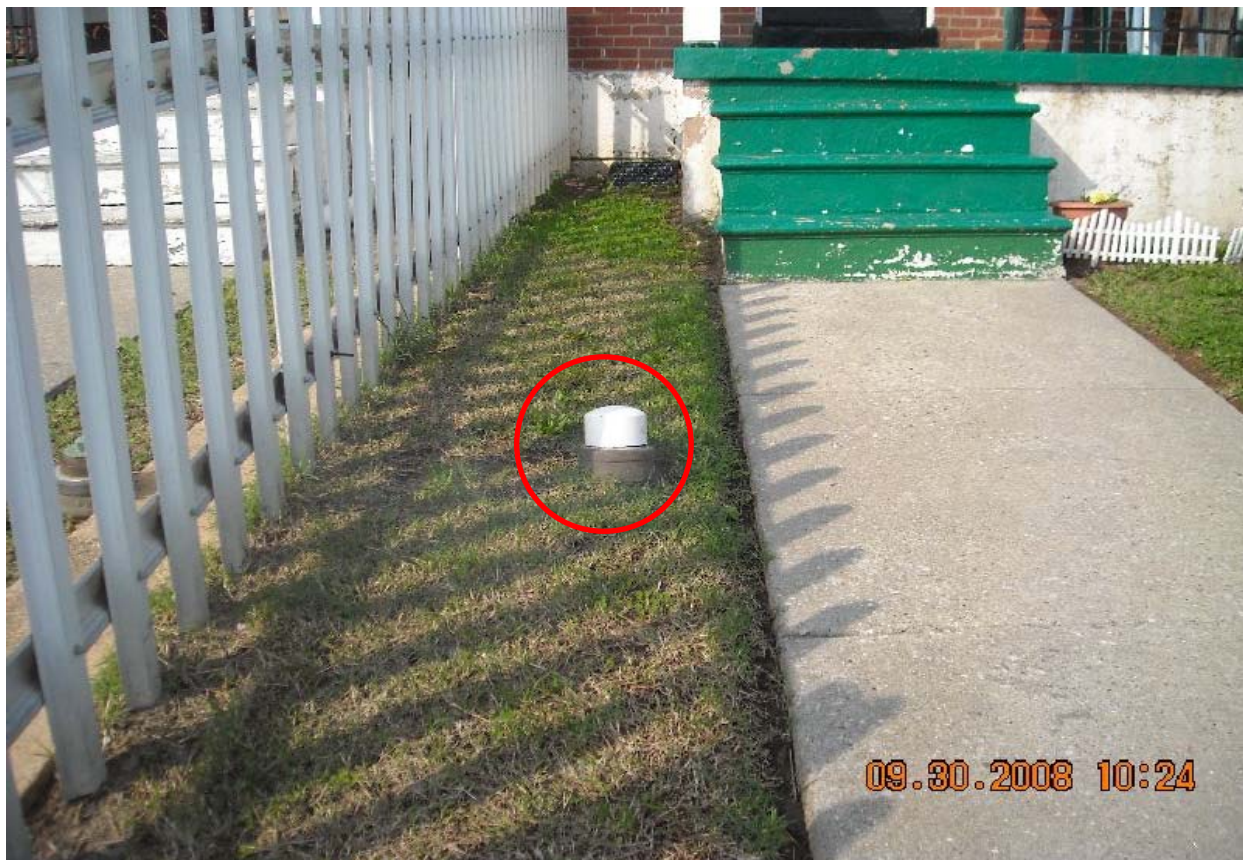
Photograph No: OB06-P01  
Filename: S1039-011\_OB06-P01.jpg

Unique Test ID: S1039-011	Date: 09/30/2008	Manhole ID: S49II_032MH
Defect No: OB06	Supervisor: E.R.	Basin: Outfall
Location: 1512 N. LINWOOD AVE.		
Source Type: 03 Cleanout	Sector: 02 Private	
Location: 07 Yard - Front	Severity: 03 Moderate	Drainage Area: 1 ft <sup>2</sup>
Comments: Smoke is coming from above grade cleanout with a broken cap at 1512 N. Linwood Ave.
